# Manhole Inspection Summary

Manhole # S45E2\_039MH

**Location** Address: **4018 Fairhaven Ave**

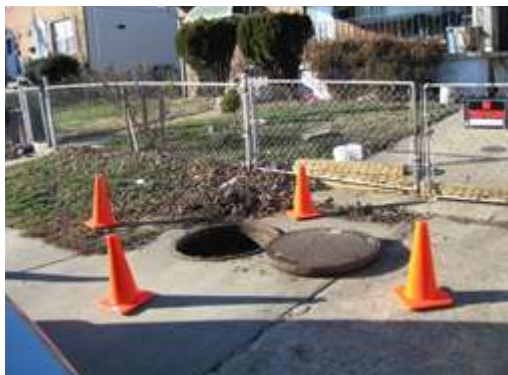
Location View

Fairhaven Ave.

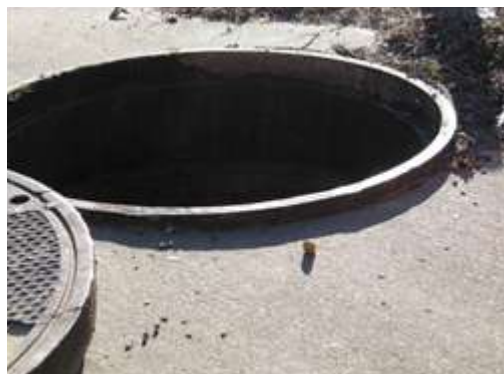
Defect 1

Above grade

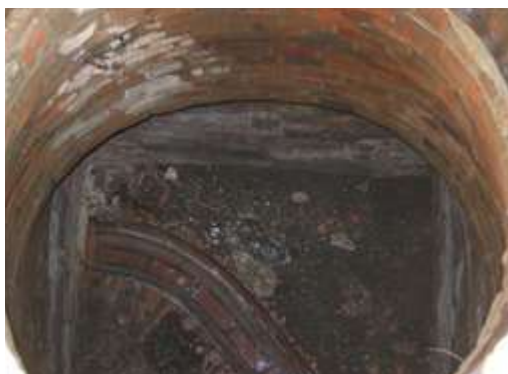
Defect 2

Debris

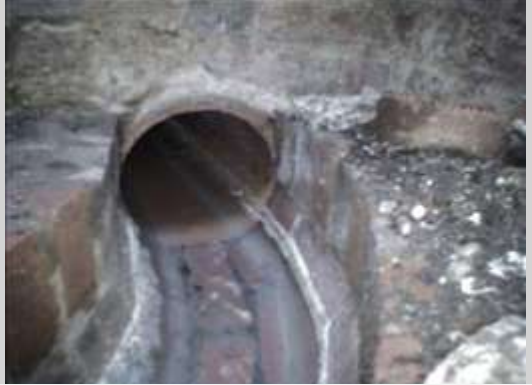
12 O'Clock Outflow

8 in. Circular Gravity Sewer  
Pipe Out @ 12 O'Clock

Pipe Height: **8.4** (in.) Rod and Bar (Angled)  
Pipe Material: **Clay** ☐ Pipe Lined  
Invert Depth: **8.94** (ft.) Flow Characteristics: **Fast**  
Deposits: ☒ None ☐ Mud ☐ Sludge ☐ Debris ☐ Grease  
Silt Depth: (in.) Deposits Extent:  
Infiltration: **None** Pipe Seal Cond: **Sound**

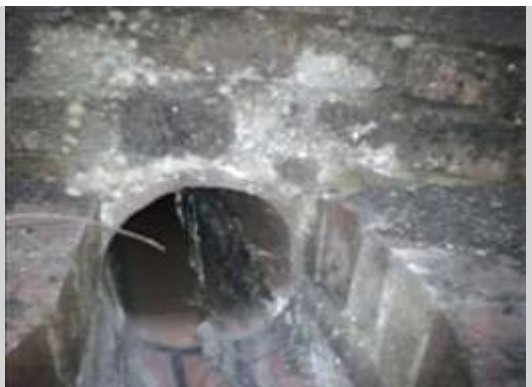
6 O'Clock Inflow

8 in. Circular Gravity Sewer  
Pipe In @ 6 O'Clock

Pipe Height: **9.6** (in.) Rod and Bar (Angled)  
Pipe Material: **Clay** ☐ Pipe Lined  
Invert Depth: **8.97** (ft.) Flow Characteristics: **Fast**  
Deposits: ☒ None ☐ Mud ☐ Sludge ☐ Debris ☐ Grease  
Silt Depth: (in.) Deposits Extent:  
Infiltration: **None** Pipe Seal Cond: **Sound**
